Camp Fortunate: A Retrofit Example

APPENDIX VI **CAMP FORTUNATE: A RETROFIT EXAMPLE**

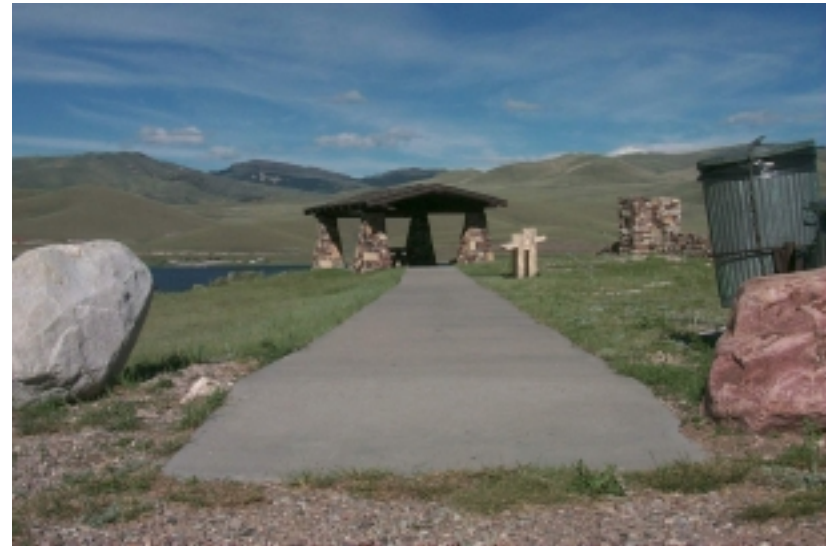
Present sidewalk entrance to picnic shelter

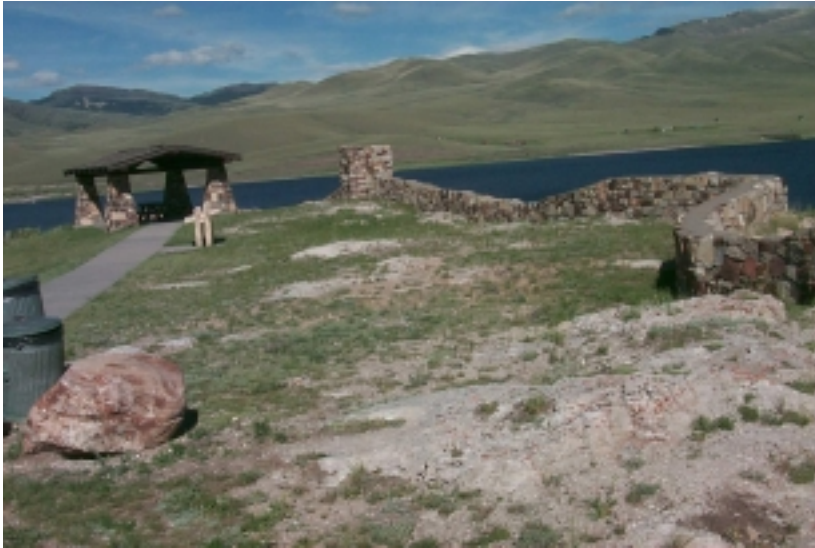
PRESENT

At present, the picnic shelter is approached directly from the parking area. After improvements, viewing shelter would be approached indirectly along rock wall providing walker a better view of reservoir below. By removing the sidewalk the obtrusive line from parking area to shelter is removed giving more emphasis to the natural setting while placing the shelter more comfortably in its surrounding. Interpretive sign, mount and pad would also be removed from sidewalk area.

Boulders should only define parking area. Removing boulders that are now present on the hillside enhances the natural open quality without isolating the setting.

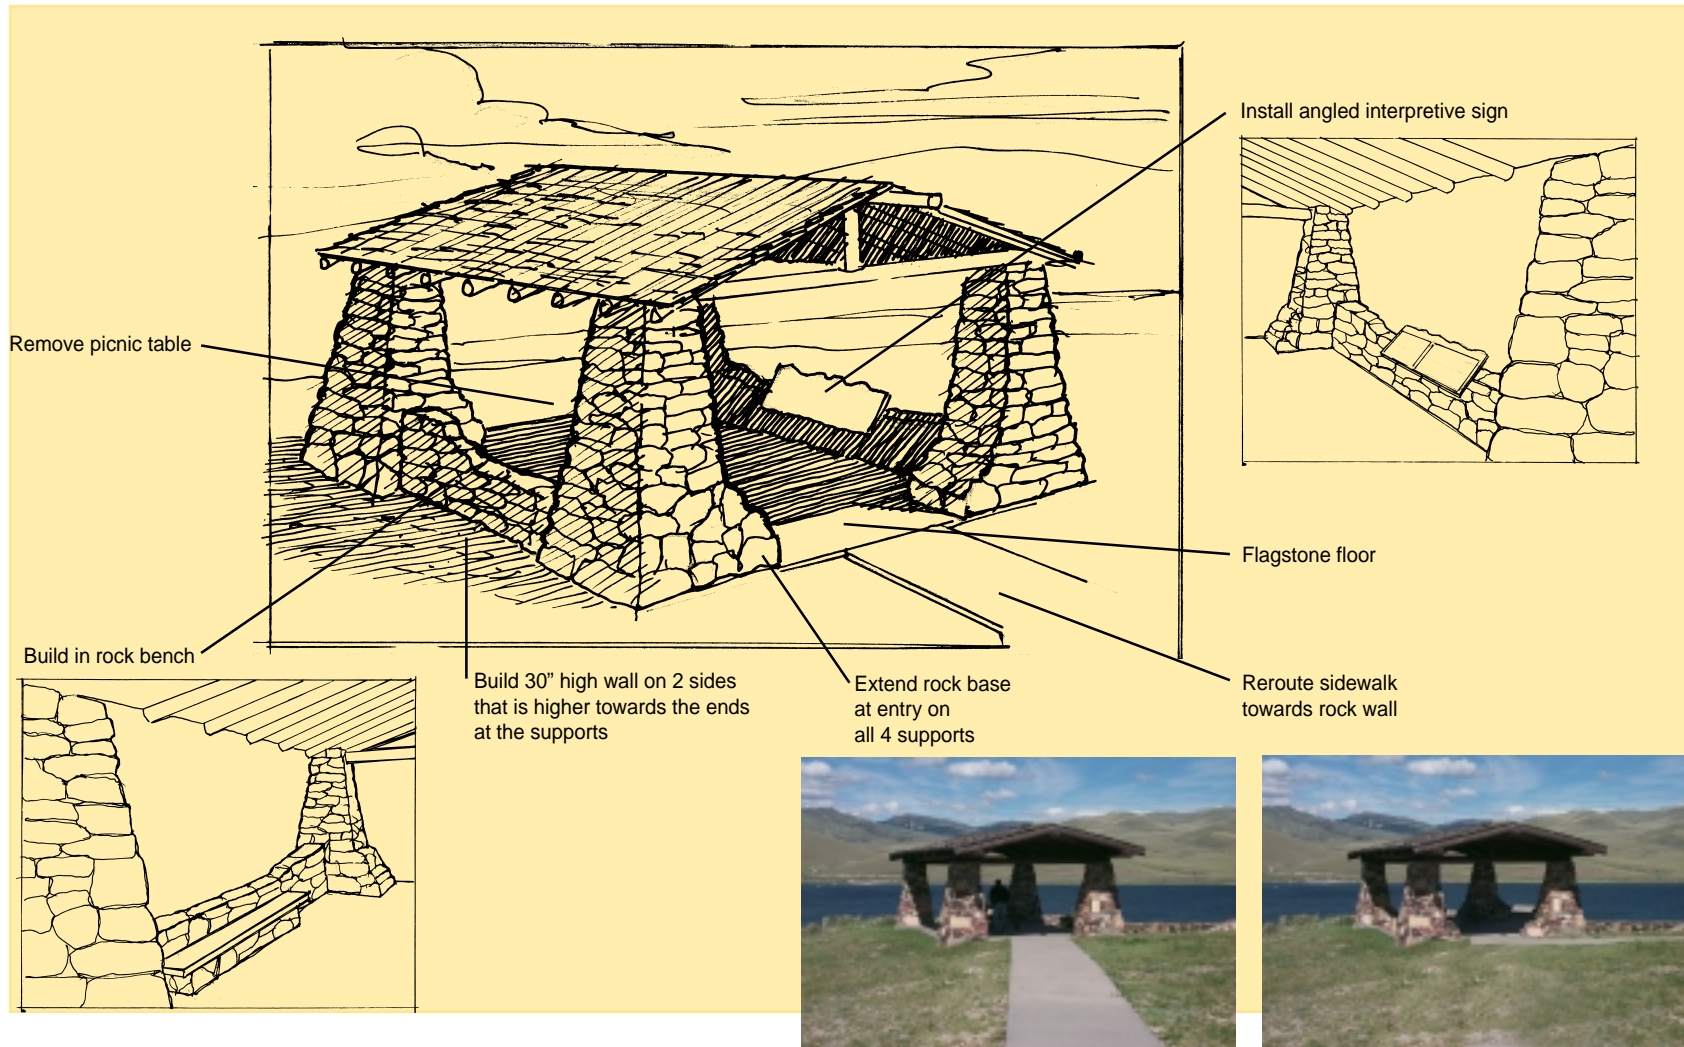
From Picnic to View Shelter

- Remove table from picnic shelter and add walling.
- Add interpretive signage and sculpture.
- Build in rock bench on back wall.

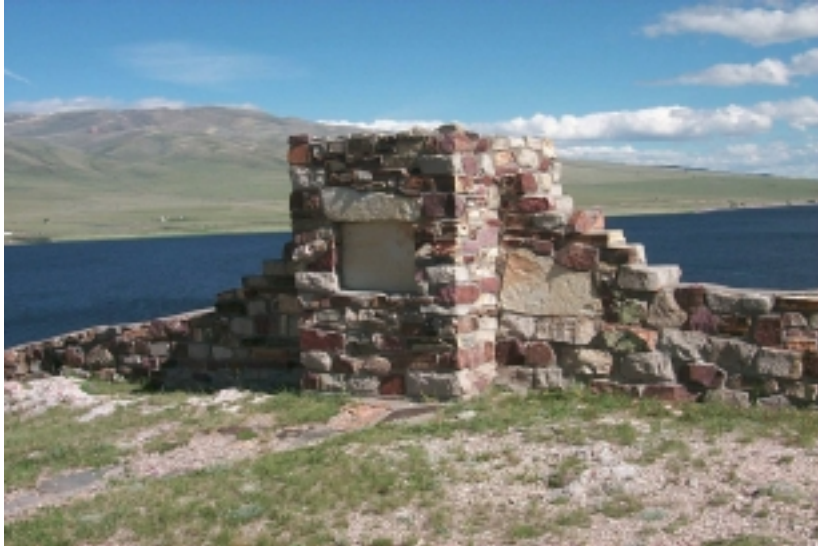
PRESENT

At present the monument placed near the picnic shelter is oddly shaped and serves little purpose. Either remove it entirely and continue the rock wall or reshape it by adding a cap and building up the shoulders with stone. The square recess on the face could contain Shoshone tribal interpretation provided by the tribe.

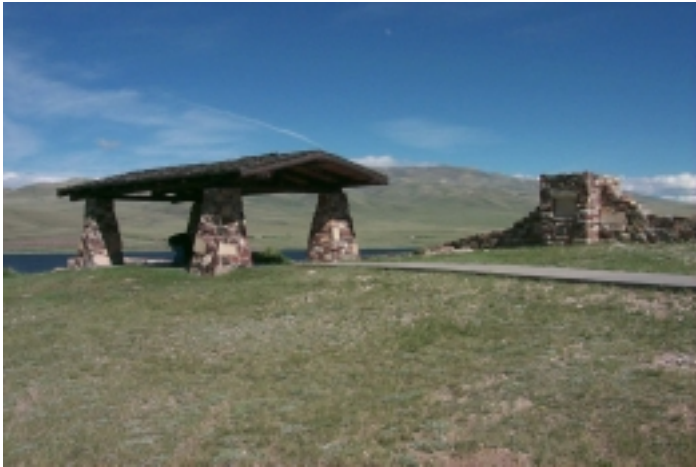
PRESENT VIEW OF PICNIC SHELTER WITH MONUMENT

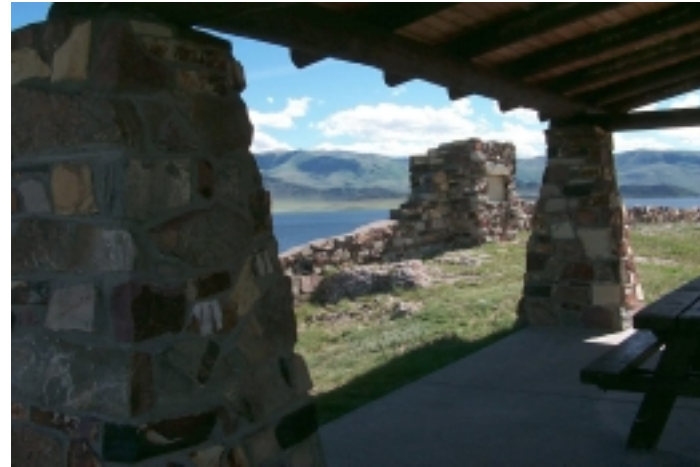
PRESENT VIEW FROM SHELTER WITH MONUMENT

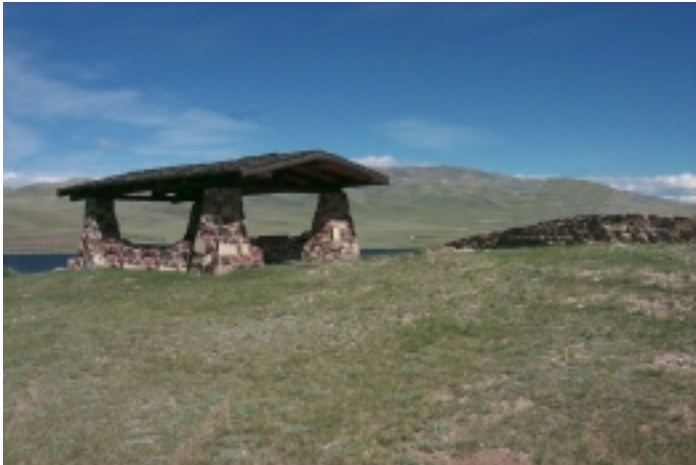
PROPOSED VIEW OF PICNIC SHELTER WITHOUT MONUMENT

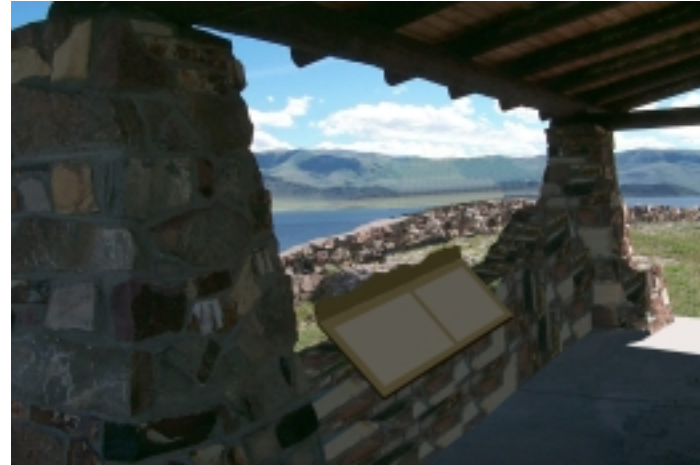
PROPOSED VIEW FROM SHELTER WITHOUT MONUMENT

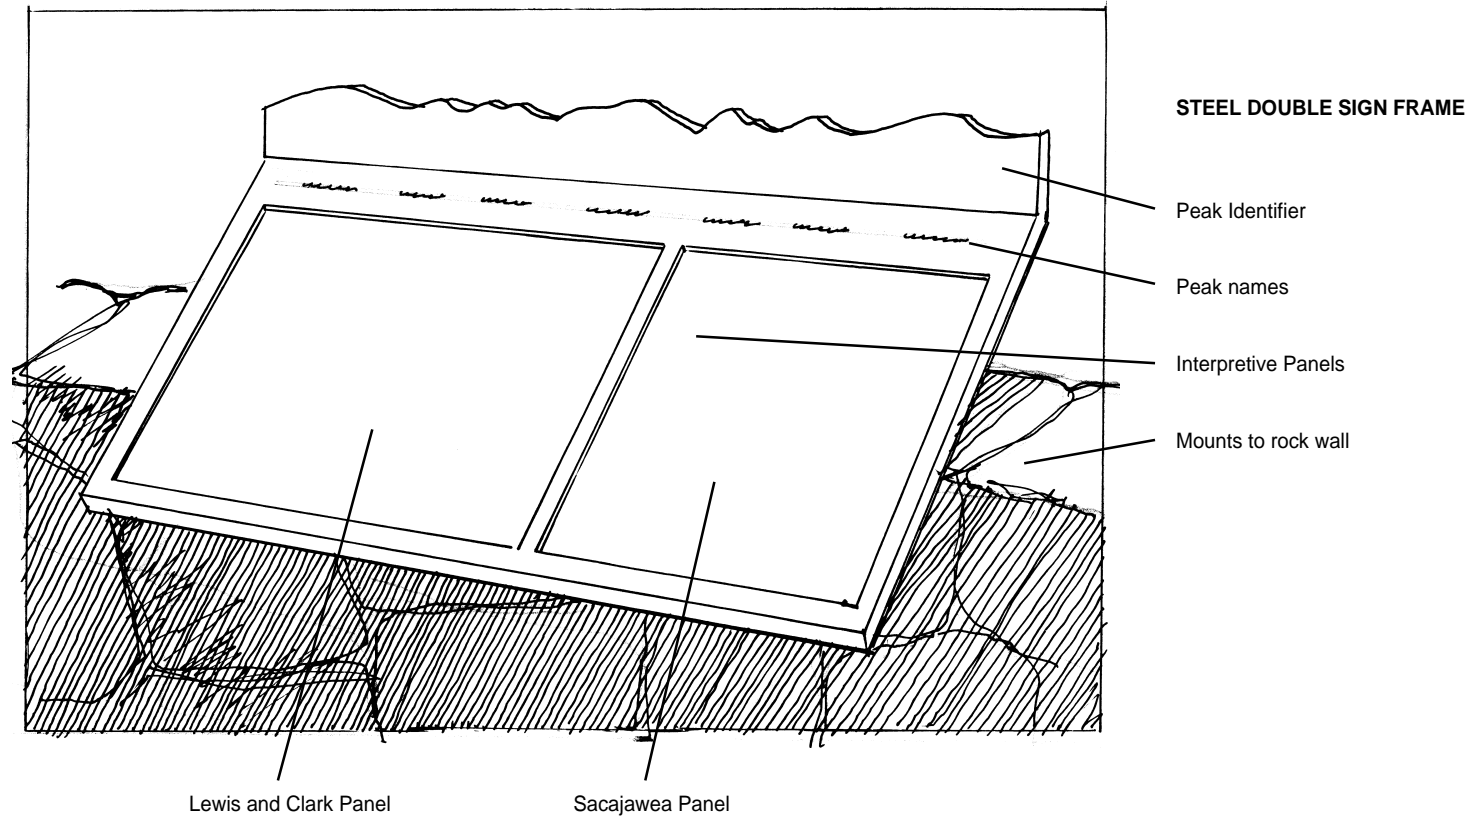
Interpretive Sign Mount

One sculpted metal frame, incorporated into low rock walling in shelter, encases both signs and includes:

- images in frame which reflect those in rock wall along bluff
- a horizon identifier along top edge of frame
